# Manhole Inspection Summary

Manhole # S13MM\_011MH

Insp Date: **9/7/07 11:38 AM**

**Location** Address: **2216 KOKO LANE**

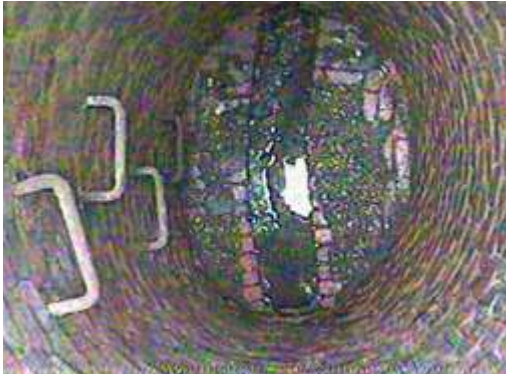
Defect 1

**Steps** Count: **7** Missing: **0** ☒ **Corroded**

CORRODED STEPS

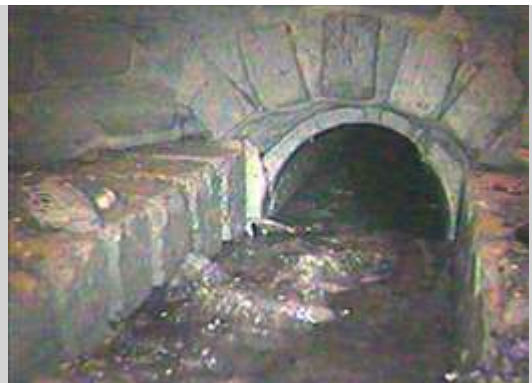
12 O'Clock Outflow

8 in. Circular Gravity Sewer  
Pipe Out @ 12 O'Clock

Pipe Height: (in.) Direct  
Pipe Material: **Clay** ☐ Pipe Lined  
Invert Depth: **10.56** (ft.) Flow Characteristics: **Slow**  
Deposits: ☐ None ☒ **Mud** ☒ **Sludge** ☒ **Debris** ☐ Grease  
Silt Depth: **3** (in.) Deposits Extent: **Medium**  
Infiltration: **None** Pipe Seal Cond: **Cracked**

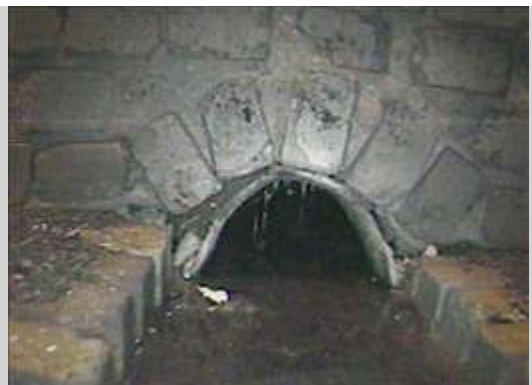
6 O'Clock Inflow

8 in. Circular Gravity Sewer  
Pipe In @ 6 O'Clock

Pipe Height: (in.) Direct  
Pipe Material: **Clay** ☐ Pipe Lined  
Invert Depth: **10.54** (ft.) Flow Characteristics: **Slow**  
Deposits: ☐ None ☒ **Mud** ☒ **Sludge** ☒ **Debris** ☐ Grease  
Silt Depth: **3** (in.) Deposits Extent: **Medium**  
Infiltration: **None** Pipe Seal Cond: **Broken**
